Experimental and analytical investigation of dynamic crack patterns in automotive windshield sheets subjected to low velocity impact

P. Shojaei Shahmirzadi, H. Saeidi Googarchin*

Automotive Fluids and Structures Analysis Research Laboratory, School of Automotive Engineering, Iran University of Science and Technology, Tehran 16846-13114, Iran

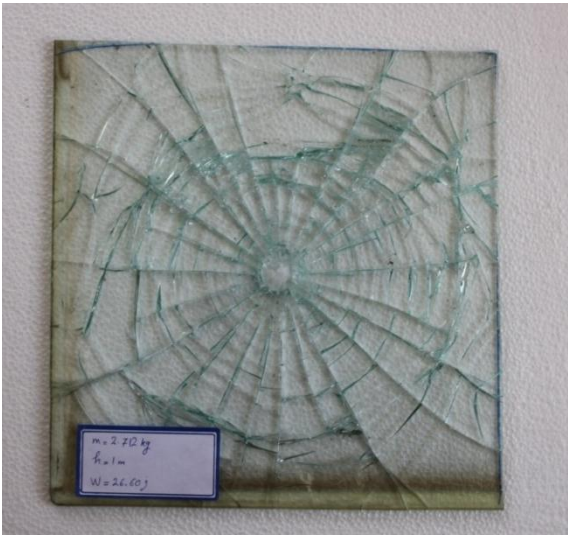
Fig14. .specimen after test code D-B-T-6

Laminated glass specimen after test code D-B-T-6 is shown in Fig.14.

As it is observed from Fig.14, the impact region at the center of specimen (powdering region) is a circle with approximate diameter of 20mm in which cracks density and consequently damage level is higher than the other regions of

specimen. In this test, the projectile has penetrated thoroughly in specimen. Therefore the glass layers have fractured and the PVB interlayer has torn. This test (test code D-B-T-6) has higher impact energy level in comparison to test code D-B-T-5. It can be observed that the penetration at the center of test code D-B-T-6 specimen is deeper than test code D-B-T-5, on the other hand the number of radial cracks is smaller in test code D-B-T-6. In fact, the impact energy has been released mostly through penetration in thickness direction and residual energy has released through radial and circumferential cracks. The radial cracks in test code D-B-T-6 are nearly symmetrical and about 24 which has decreased about 20% in comparison to test code D-B-T-5, but the penetration depth has

increased about 50%. It shows that approximate 76% increase in impact energy level in test code D-B-T-6 in comparison to test code D-B-T-5, has been released mostly through increase in penetration depth and radial and circumferential cracks in further priorities.

There are 6 circumferential cracks in the specimen at the radiuses of 34,41,51,60, 70 and 95mm from the center of the laminated glass sample. It can be seen from Fig.14 that the radial cracks have been initiated from the impact surface of laminated glass and propagated along thickness direction. In one side of the laminated glass, sectors of circumferential cracks like grids, have connected radial cracks to each other. 12 out of total 24 radial cracks have extended to the borders of the specimen and released their internal impact energy by this way. The acceleration versus time graph of test code D-B-T-6 is illustrated in Fig.15
