Experimental and analytical investigation of dynamic crack patterns in automotive windshield sheets subjected to low velocity impact

P. Shojaei Shahmirzadi, H. Saeidi Googarchin*

Automotive Fluids and Structures Analysis Research Laboratory, School of Automotive Engineering, Iran University of Science and Technology, Tehran 16846-13114, Iran

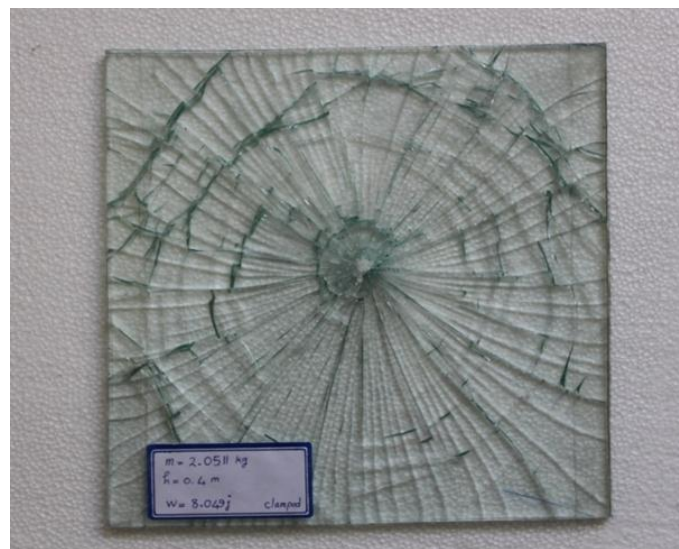
Fig10. .specimen after test code D-B-T-4

Laminated glass specimen after test code D-B-T-4 is shown in Fig.10.

As it is observed from Fig.10, the impact region at the center of specimen (powdering region) is a circle with approximate diameter of 20mm in which cracks density and consequently damage level is higher than the other regions of specimen. The projectile has penetrated to the depth of 1-1.5mm of the laminated glass and due to 2.5mm thickness of glass layers, no elongation has been occurred in PVB interlayer. Although energy level of test code D-B-T-4 is higher than test code D-B-T-3's one, penetration at the center of specimen is less in test code D-B-T-4 which

can be representative of impactor's mass influence. In test code D-B-T-4, the impactor mass is 2.0511kg, while it is 2.0712kg in test code D-B-T-3, therefore it can be concluded that in 2 similar conditions, the less impactor mass, the less penetration depth at the center of specimen.

It is easily seen from test code D-B-T-4 specimen that cracks have initiated from the impact surface and propagated through thickness. In this test, one circumferential crack has been propagated which is at the radius of 95mm from the center. Besides, some sectors of circumferential cracks have been made at the

radiuses of 62, 70 and 80mm from the center of specimen and serve as bridges to connect radial cracks. Also it can be seen from the laminated glass that the radial cracks in test code D-B-T-4 are nearly symmetrical and about 84. After drawing a comparison between test code D-B-T-4 and test code D-B-T-3, it is obvious that radial cracks of test code D-B-T-4 are more than their counterparts in test code test code D-B-T-3, on the other hand circumferential cracks of test code D-B-T-3 are more than test code D-B-T-3's ones. At test code D-B-T-4, distance between radial cracks is shorter than its corresponding item in test code D-B-T-3.

At all 4 sides of specimen which was clamped during the test, diagonal asymmetrical

net shaped cracks have been made which have created some right triangles in margins of the specimen. Diagonal net shaped cracks at the margins of test code D-B-T-4 specimen are more congested in comparison to the whole radial cracks. In addition, at both upper and lower glass layers, radial cracks converge at the center of the specimen and their divergence increases at larger radiuses. The acceleration versus time graph of test code D-B-T-3 is illustrated in Fig.11. As it can be seen from the graph, the maximum acceleration imposed to projectile is 732.0356 m/s^2 which is occurred at 0.000131s.
