## Study of the effect on manufacturing parameters on the fatigue behavior of aluminum engine mounting bracket

Hossein Khalajzadeh<sup>1</sup>, Seyed Vahid Hosseini <sup>\*1</sup>, Alireza Shaterzadeh <sup>1</sup>

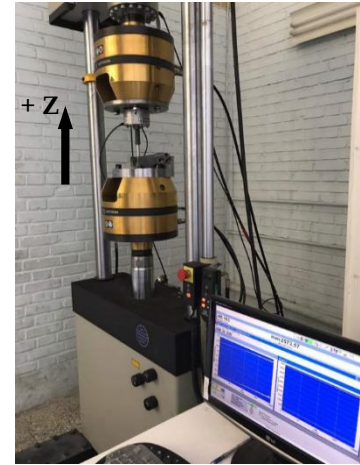
**Figure 1.** Fatigue test with Instron machine in Z direction.

Since the engine mounting bracket plays an essential role in the car, it must be designed and built in such a way that it has high fatigue resistance. In order to assess the fatigue life of the engine mounting bracket, it is imperative to conduct fatigue tests along the Z axis direction [22]. The initial measure, with the purpose of positioning the engine mounting bracket appropriately with repeatability and securing the engine mounting bracket throughout the test, is required. Therefore, the fixture was designed according to the geometry of the part and the requirements of the test. VCN 150 was used to make the main body of the fixture to perform the test in the Z direction due to its good strength, rust resistance and initial hardness of about 35 Rockwell C. The dimensions of the fixture are designed and built according to the dimensions of the device and the work piece. Subsequently, the fatigue test was conducted on the engine mounting bracket employing an Instron 8802 hydraulic servo machine proudly manufactured in England, possessing a remarkable capacity of 250 kN. The dynamometer sensor used is 25 kN manufactured by Instron, which is shown in Figure 1.
